## A Second Fracture in a Preview Fix Mandible

### Abstract

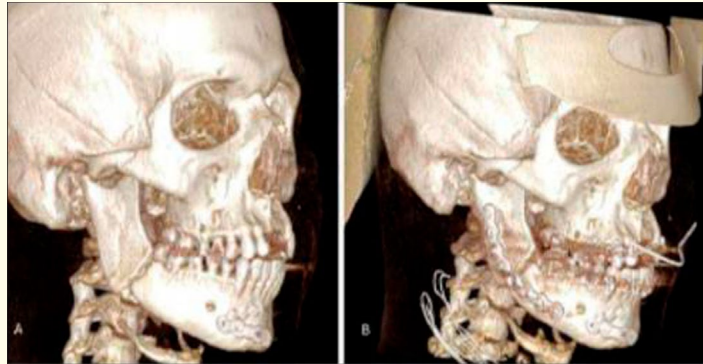
Fractures of the mandible are common in large cities and are associated with various etiologies, especially those involving dissipation of forces or deceleration that affects the lower third of the face. Management basically involves restoring occlusion, which serves as a guide and a goal to be achieved. Plates and screws make up the basic armamentarium for treating these fractures. In Brazil, many fast delivery services are carried out by motorcyclists and this, combined with the often-disorganized growth of cities, means that motorcycle falls are among the main causes of mandible fractures [1]. This situation has been aggravated by the recent COVID-19 epidemic, when many workers lost their jobs and started working for fast delivery services using motorcycles [2]. We noticed an increase in patients with a second mandibular fracture who had already been treated for a previous mandibular fracture (Figure 1).

**Figure 1:** Fracture of the mandibular angle in a patient who had already been treated for a fracture of the symphysis due to a fall from a motorcycle [A] and Post-operative control picture with universal reconstruction plate fixation [B].
