An Effective Approach to Remove a Fractured Endodontic Instrument

Clinical case

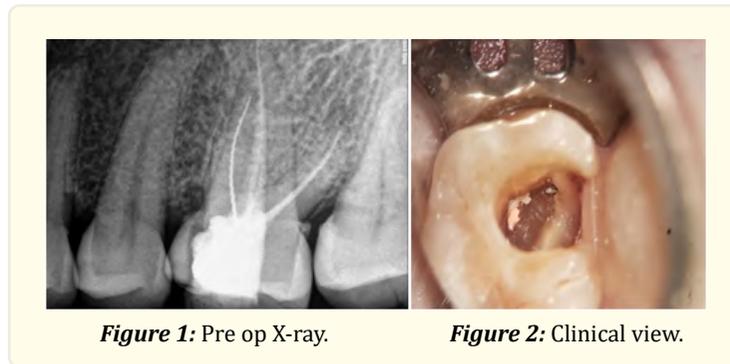
A pre-operative radiograph was taken and it was noted that a large portion of an endodontic instrument fractured inside the mesio-buccal root canal (Figure 1). The restoration was removed to expose the obturation material. Gutta-percha was eliminated from the palatal and disto-buccal canals. The Dental Operating Microscope (DOM) (CarlZeiss, Oberkochen, Germany) was used to obtain straight line access and visualize the fractured instrument (Figure 2). The root canal was flooded with 17% liquid EDTA and activated using ET25 tip of Endo Success TM Retreatment ultrasonic file in an effort to remove debris and inorganic matter and improve visualization of the fractured instrument. The tip was placed on the upper part of the separated instrument. Ultrasonic insert was used and moved in "push and pull" motions between the fractured instrument and the inner wall of the root canal (figure 3). A home-made retrieval system based on Hedstrom file 15 and a modified 27-gauge needle was used as a substitute for a canceller extractor.

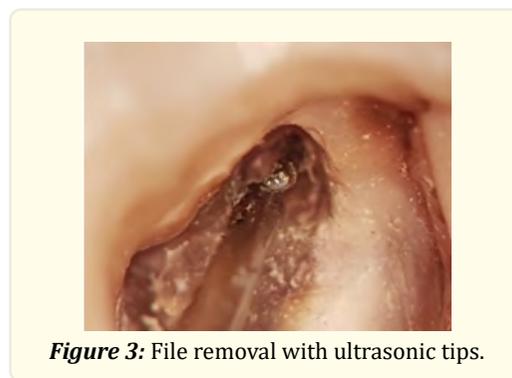
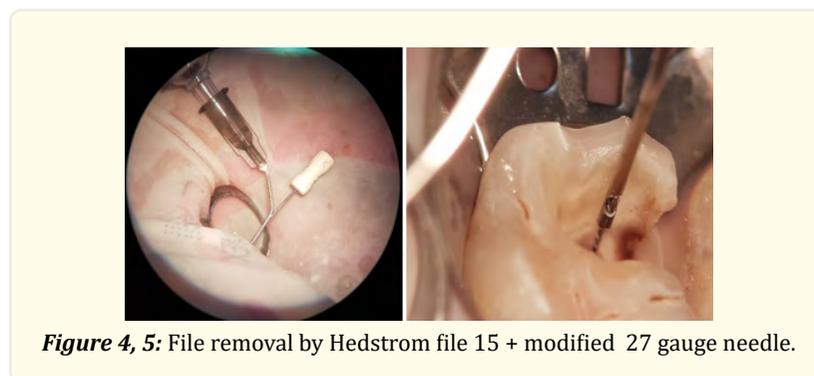
This sequence was repeated 3 times to ensure having good taking of the upper part of the instrument (figure 4, 5).

In this case report, the ultrasonic insert was employed due to its interest in the management of fractured instruments, such as tissue saving, as well as a specific and compatible instrumentation design. Also, the employment of the home-made retrieval system was efficient to preserve radicular dentin tissue, the hedstrom file blocks the instrument and the needle is inserted on its totality to extract it without risk of losing it [3].

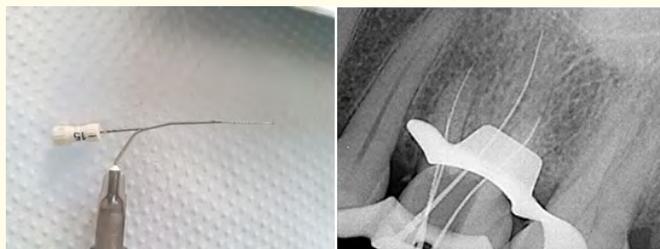
Figure 6: A large segment of a fractured instrument fixed on the tube of the needle after removal from the root canal.

Figure 7: Working length determination.

The canal was dried and small K files were introduced in a gentle pecking motion with slight apical pressure in order to determine the working length (Figure 7) the optical aid was of great help to visualize the 4th MV2 channel, ultrasonic activation of NaOCL 3% and viscous 15% EDTA paste as well.

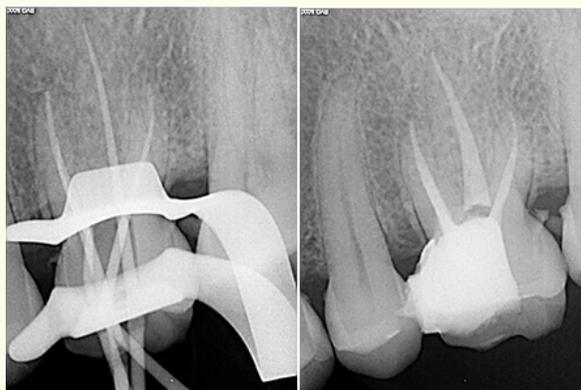
Figure 8: Cone fitting, MB1 MB2 is convergent type II according to Vertucci classification.

Figure 9: completed obturation with bioroot by hydraulic obturation condensation.

Shaping of all canals was completed using the ProTaper Universal system and root canals were irrigated in a similar technique as described above. The root canals were dried slightly using large paper points. Obturation was completed by Hydraulic condensation technique with Bioroot RCS (Septodont) (figure 8, 9).
