Fiber Posts in Dentistry

Case Presentation

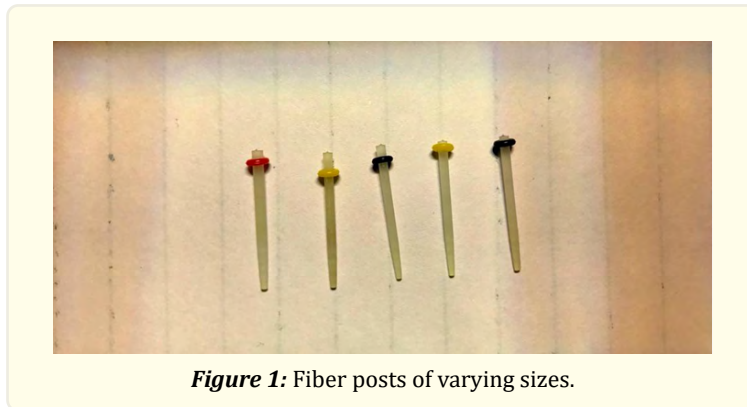
Figure 1: Fiber posts of varying sizes.

Different types of posts include prefabricated metallic posts, fiber posts, Zirconia posts.

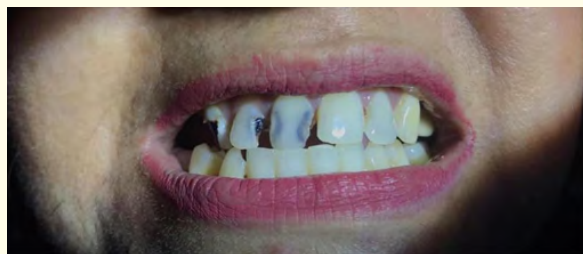
A middle aged lady visited the clinic a few weeks back. She was reluctant and unwilling to smile because of the blackening of her upper anterior teeth (as seen in Fig-2). She was advised by her earlier dentists to get the anterior teeth extracted and go for implant prosthesis. But she was unwilling to get her teeth extracted. Hence the decision was taken to perform RCT followed by Fiber posts and then eventually full coverage zirconia crowns would be placed. RCT (Root Canal Treatment) was done in the right maxillary central incisor; the right maxillary lateral incisor; the right maxillary canine and the left maxillary lateral incisor (because the left maxillary lateral incisor was completely decayed on the palatal side that is not being visible in the Fig-2). After obturation, PeesoReamers (seen in

Figure 2: Pre treatment photograph.

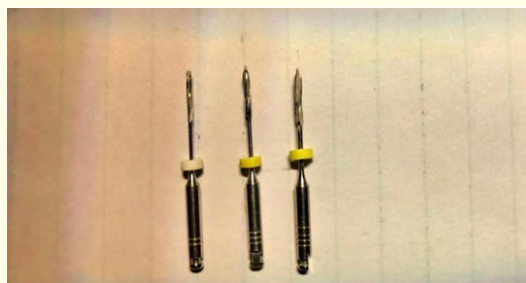
Figure 3: Peeso Reamers used for the removal of gutta percha.

Fig-3) were used to remove Gutta Percha from the canals of right maxillary canine and the left lateral incisor. The gutta percha was removed in such a way that only 5-6mm of gutta percha was left in the canal apically. The peeso reamers were used cautiously to remove the gutta percha and enlarge the canals keeping in mind not to sacrifice any more of the remaining dentinal structure. The Fiber Optic light transmitting posts (as seen in Fig-1) of the desired size were selected. The posts were first coated with Te-EconomBond (Universal dental adhesive by Ivoclar Vivadent as seen in Fig-4) and then light cured for 10 seconds. Coltene SoloCem Dual Cure resin cement (as seen in Fig-4) was then placed inside the canals. The posts were also adhered with the Coltene resin cement prior to their placement inside the root canals. Fiber optic posts were then placed in the right maxillary canine and the left lateral incisor (that is visible in the IOPA, Fig-3) followed by light curing from all sides for 30 seconds. Full ceramic zirconia crowns were fabricated and cemented with Coltene dual cure resin cement. The patient was very happy with the final result (as seen in Fig-8) and she got her smile back again.

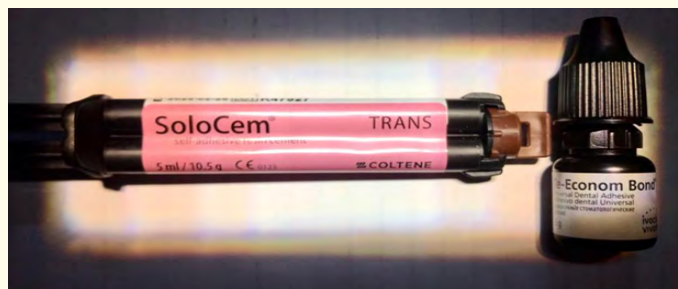
Figure 4: Luting (as well as core build up) Cement and bonding agent used.

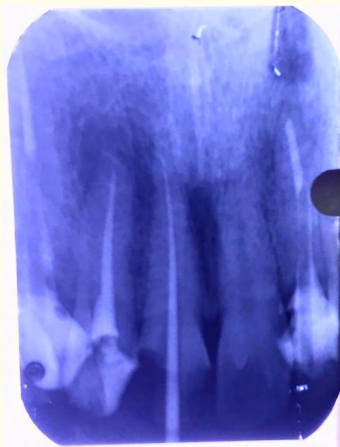
Figure 5: The IOPA posted here was during the master cone selection of the right maxillary central incisor after the completion of the RCT of the other 3 teeth and placement of fibre optic post but prior to final core build up.

N.B-The IOPA posted here was during the master cone selection of the right maxillary central incisor after the completion of the RCT of the other 3 teeth and placement of fiber optic post but prior to final core build up.

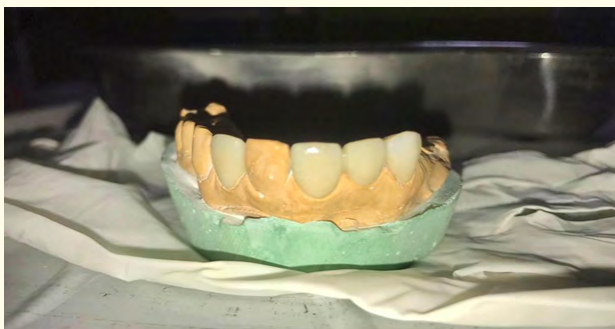
Figure 6: Labial view of the full ceramic Zirconia crowns.

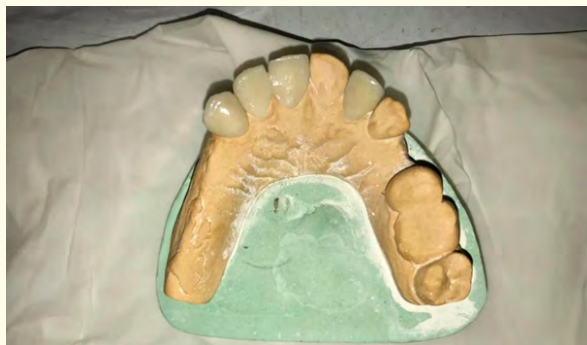
Figure 7: Lingual view of the full ceramic Zirconia crowns.

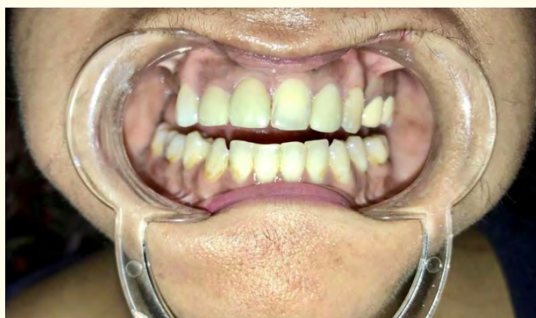
Figure 8: Post treatment photograph after crown cementations.

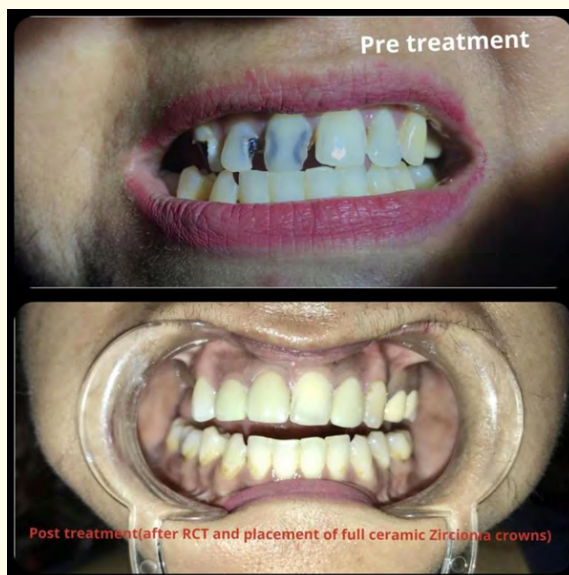
Figure 9: Final photograph of the patient comparing the pre and post treatment photographs.
