Gypsiferous Soils and *Gypsum* Beds

Hayder A Al-Bahadily*

Department of Geology, Iraq Geological Survey (GEOSURV), Iraq

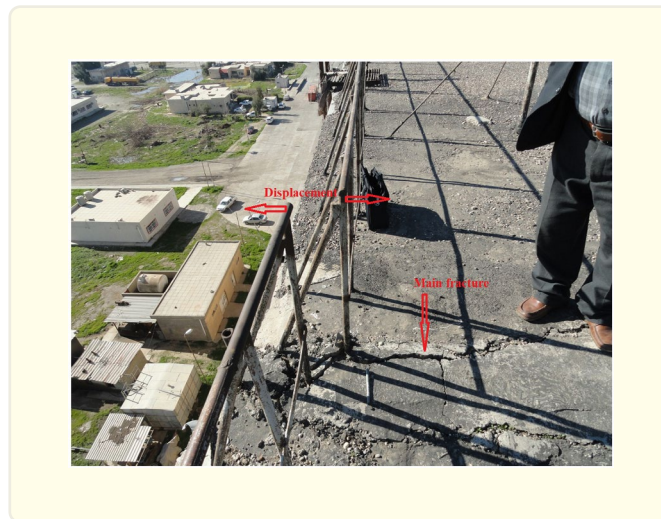
Photo on the top of the main building of Kirkuk Silo showing cracks and a horizontal displacement resulted in differential subsidence and rotation (note the pen as a scale). The photo was taken by Hayder A. Al-bahadily.

In the plains and lowlands, where eroded *gypsum* is redeposited, buildings constructed on gypsiferous soil will suffer from differential subsidence (see the photo below, from Kirkuk Silo, north Iraq) that causes exorbitant economic damage and considerable (geological) risks. Such dissolution also causes floor depressions, wall and roof cracks, and vertical and horizontal wall displacements.
